# ROOFING

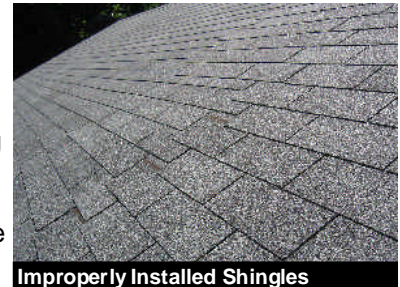
REPAIR or REPLACE - Mechanical / physical damage is present at the first few courses of shingles. In my opinion, this can allow water leakage and water entry into the building. Water leakage can lead to various problems, and can lead to a mold problem. Appropriate corrective action is recommended by a qualified roofing contractor.
