# EXTERIOR

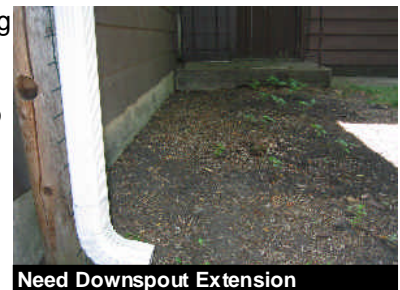
REPAIR or REPLACE - The gutter on the secondary roof is missing a downspout. In my opinion, a downspout should be installed to allow water to drain freely. Recommend contacting a reputable gutter and downspout contractor to mitigate the situation.
