# **GARAGE**

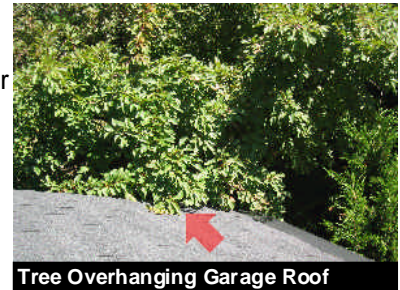
MAINTENANCE - Tree branches are touching the roofing material. In my opinion, this damages the shingles and reduces their expected life span. Additionally, anytime roofing material is damaged, the potential for water leakage is present. I recommend having the tree branches removed from over the house by a qualified professional.

**Tree Overhanging Garage Roof**
